Nonpoint Source Pollution Assessment Report And Management Plan

MATFIELD AND SALISBURY PLAIN RIVER WATERSHEDS

ESS Group, Inc.
888 Worcester Street, Suite 240
Wellesley, Massachusetts 02482

November 4, 2003

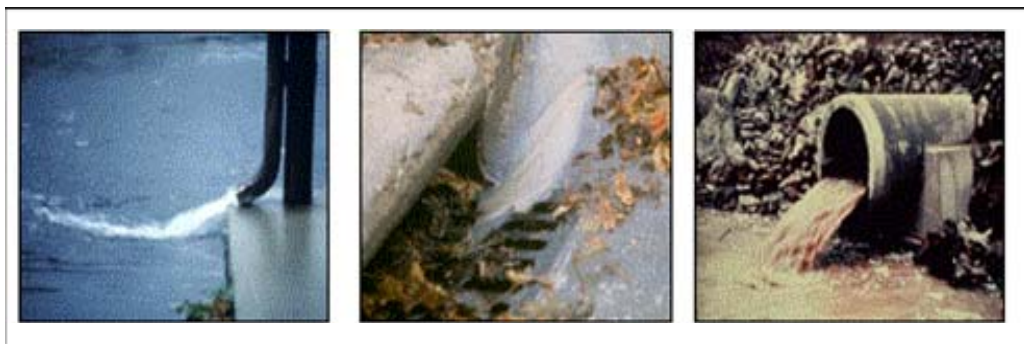
Many areas within the Study area have stormwater and sedimentation problems which were identified during field reconnaissance for water quality sampling, town site visits, and water quality reports. These sites are problem areas that should be considered for stormwater and sediment structural BMPs either because of the size of the areas they drain, the land uses they are draining, and/or the resources they are draining to. In most cases these resources are small streams that feed the main tributaries to the rivers in the Matfield and Salisbury Plain watersheds.

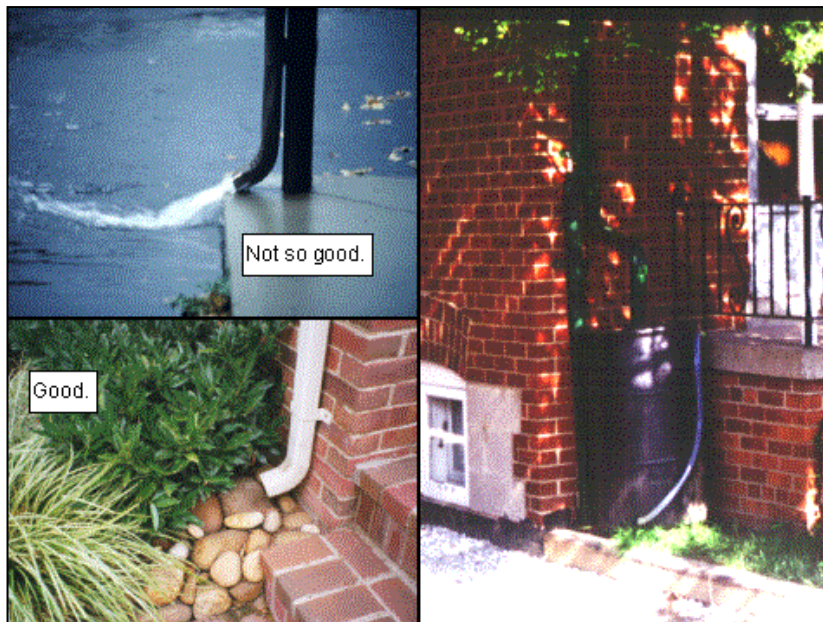
Because choosing a structural BMP is dependent on the characteristics of the site, it would be helpful to the communities to have a reconnaissance study completed of the stormwater problems identified in this report. The reconnaissance study could list the factors needed to determine an appropriate BMP including such physical constraints as soil conditions, watershed size, depth to water table, depth to bedrock and slope, etc.

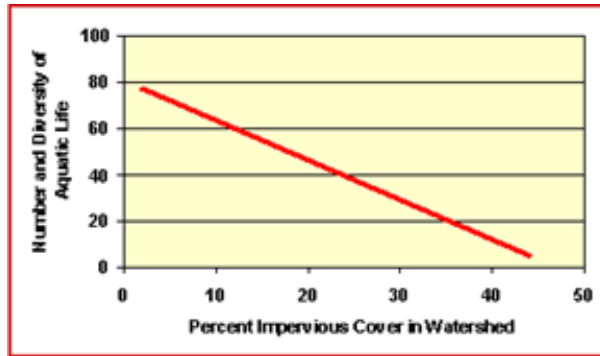
Permeable pavements can be an effective means of reducing the area of imperviousness in a watershed. In cases where a community is close to full development and in urban areas, removal of impervious surfaces and replacement with permeable pavement can be a solution to stormwater runoff problems.

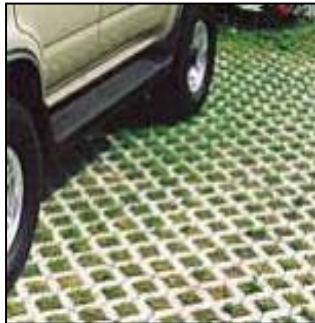
The Center for Watershed Protection notes that porous pavements (including permeable asphalt mixes and pavers) are best suited for low traffic areas, such as parking lots and sidewalks and that the most successful use of permeable pavements are found in areas with sandy soils and flatter slopes (Center for Watershed Protection, 1998). Permeable pavements allow stormwater to infiltrate into underlying soils promoting pollutant treatment and recharge, reducing the amount of stormwater and overland runoff to drainage systems that discharge into streams and wetlands. Costs for paving blocks and stones range from \$2 to \$4, whereas asphalt costs \$0.50 to \$1 (Center for Watershed Protection, 1998). Municipalities that have extensive areas of commercial land use where parking lots and large buildings create overland runoff would benefit from requiring new development and renovations to utilize pervious surface materials where appropriate.

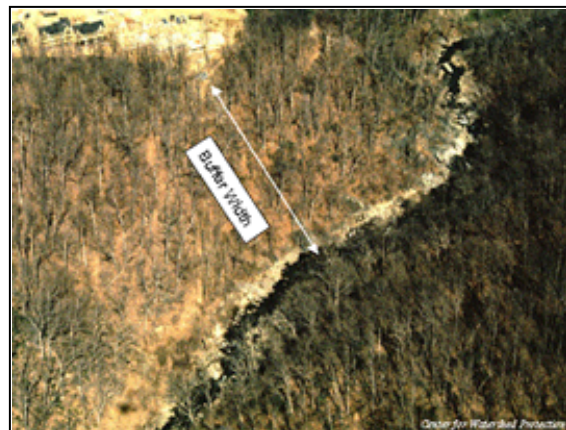
Vegetated buffers can remove sediment and attached pollutants from surface water runoff. The effectiveness of vegetated buffers depends on a number of variables including soil type, water table depth, type of vegetation, land-use and drainage areas (Desbonnet et al. 1994). Vegetated buffers are required by many municipal and state authorities throughout the United States. They have
